EXHIBIT “A-2”

Electrolux / General Electric Design

The subject dryer designs employed by Electrolux in their 5.7/5.8 Cu. Ft. dryers were evaluated and the following hazards related to the risk of fire were identified:

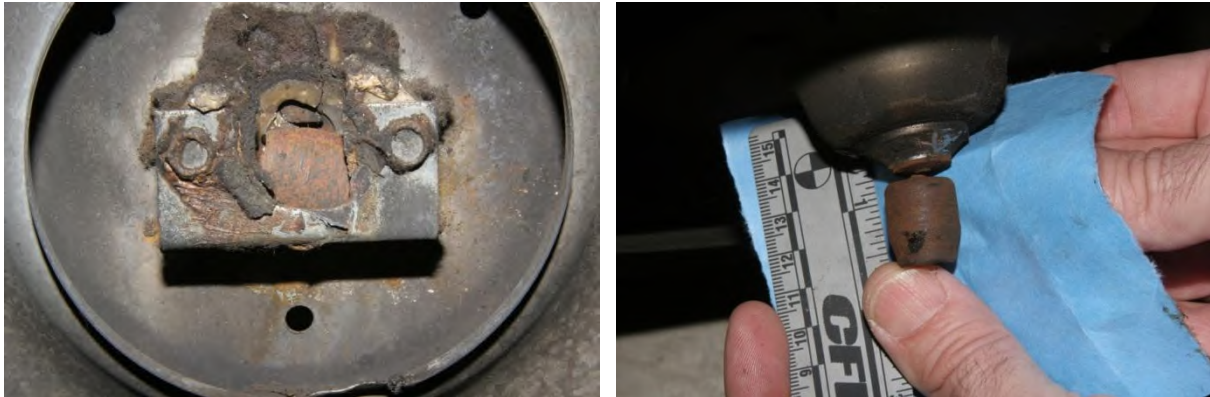
Example of Damage Related to a Bearing Failure

The first is a bearing failure that results in fire when the single rear bearing assembly that suspends the drum from the center of the heater housing fails, causing the rear of the metal drum and its clothing load to shift from its original position. When this occurs while the dryer is operating, the metal baffle/heat shield attached to the rear of drum contacts the energized heating element located approximately one inch from the rear of the drum, which results in a ground fault. This electrical short emits hot molten metal into the cabinet in the area at the rear of the drum. Any lint accumulated on the rear of the drum or within the cabinet can be ignited. The hot molten metal can also pass through the perforated ventilation openings in the rear of the drum and ignite the clothing load, particularly if the load is dry. The ability for the molten metal to be drawn into the rear of the drum is compounded by the negative pressure caused by the operating blower fan assembly, pulling air from the direction of the heating element behind the drum, into the clothing and toward the lint filter assembly at the front of the drum. It should be noted that other electric dryers of the other manufacturers' design types do not have their heating element located in this same location. Instead they are located in a metal duct in the cabinet below the drum. This eliminates the possibility of a bearing failure of any caliber to allow the drum to contact the heating element under any circumstances.

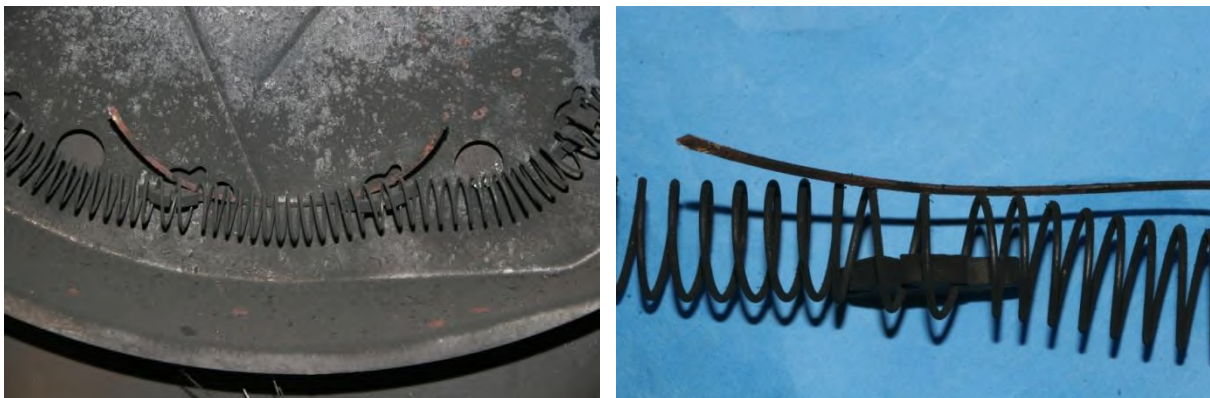
Example of Foreign Objects Contacting the Heating Element

The second fire cause scenario also relates to the heating element location directly behind the drum. Metallic objects from the clothing load can pass through the numerous ventilation perforations in the rear of the drum and enter the heater housing. If any of the items should contact the heating element while the heating element is energized, an electrical short can occur. The ground fault of the object between the heating element and any grounded metal component of the dryer, such as the heater housing or rear of the drum, would also result in the release of hot molten metal lint accumulated within the cabinet or into the air stream pulling the air from behind the drum into the lint accumulated at the rear of the drum or clothing in the interior of the drum. Ignition of lint and other combustibles can also occur when the foreign object forms a high resistance connection at the heating element. Items associated with this fire cause includes any clothes that contain metal objects, in particular under wire bras, or any small foreign objects accidentally left in the pockets of clothing, such as a bobby pins.
